# Assessment of safety performance level on simple urban residential building: Case study at Bogor city Indonesia

M Lutfi<sup>1</sup>, H Arien<sup>2</sup>, M Hendrawati<sup>3</sup>, P J Ramadhansyah<sup>4</sup> and N I Ramli<sup>4</sup>

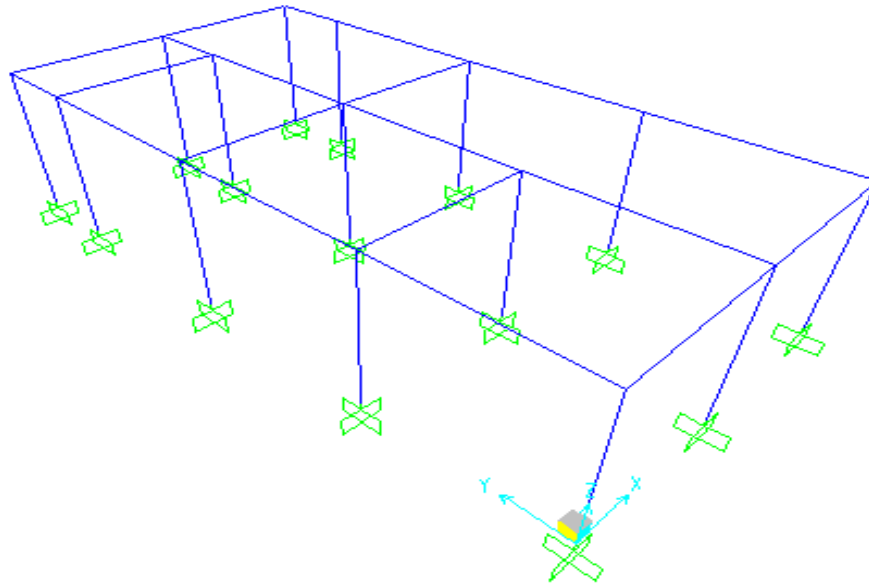
**Figure 2.** Structured modelling

The chart is then modeled in 3D using the SAP2000 V10 application, shown in Figure 2.
